# USAF PRAM PROGRAM FINAL REPORT

SACRAMENTO AIR LOGISTICS CENTER (AFLC)  
McCLELLAN AIR FORCE BASE, CALIFORNIA 95652

## PRAM PROJECT

FLASHLAMP DEPAINTING SYSTEM

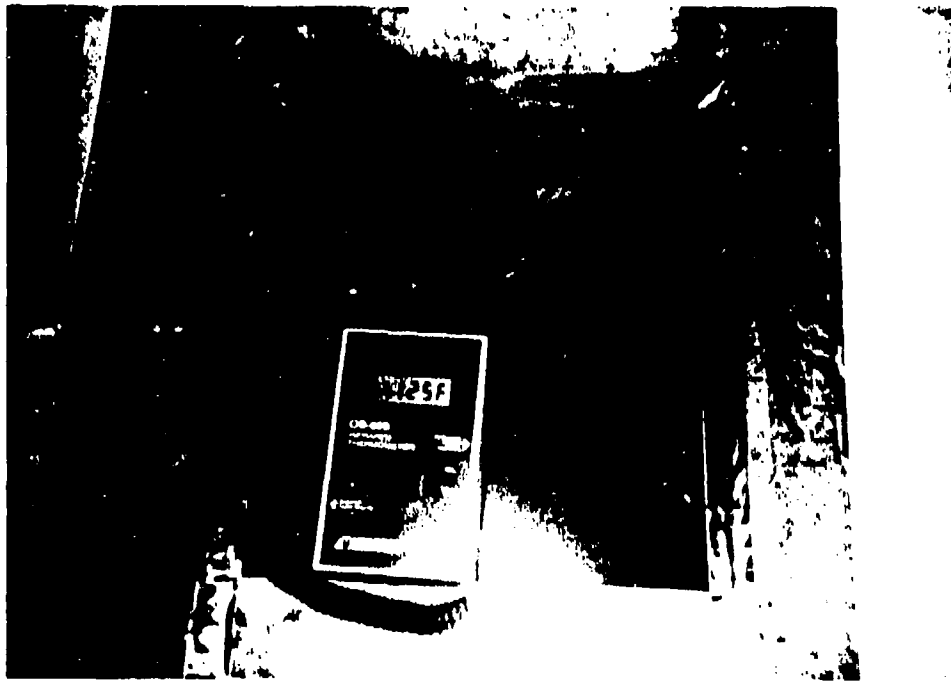
FIG. 1  
Temperature reading immediatly after flash blast.

(1) Twelve graphite/epoxy test panels from AFWAL/MLSE were primed per MIL-C-233770 and painted per MIL-C-83286B. These panels were aged at 120°F for seven days prior to shipment to McClellan for flashlamp depainting. The twelve panels were depainted using the flashlamp set-up and conditions given in Atchs 3 and 4 respectively. The power output settings of the flashlamp range from 75-100%, with the total pulse counts varying from 34 to 311 to strip the paint from the graphite/epoxy composite panels. The temperature measured by an infrared thermometer during the stripping operation increased from 30°-50°F (Atch 5).

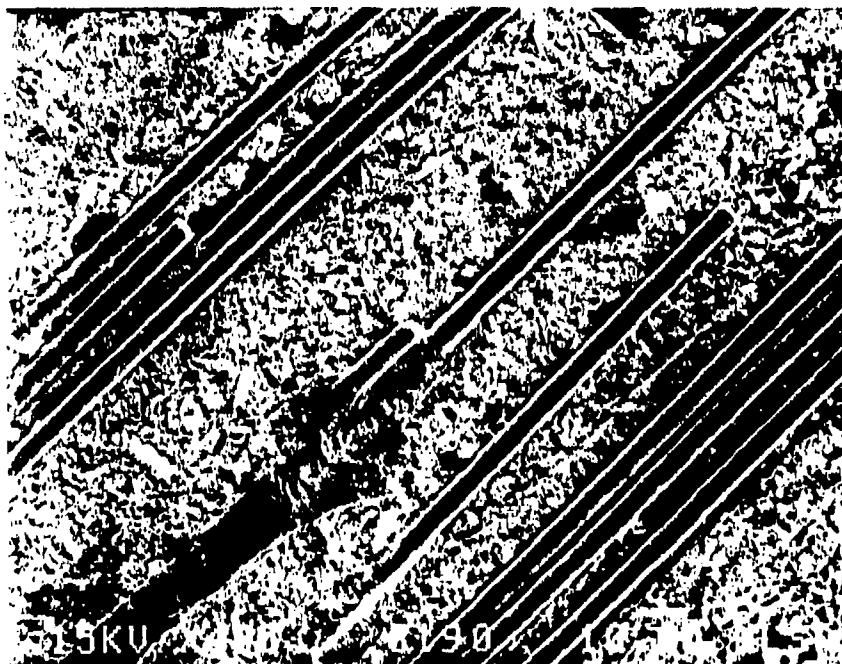
Figure 18.  
Higher magnification of the surface of specimen #9 showing bare and broken 45 degree fibers. (480x)
